Operational Inspection Report

Great Notley Play Area & MUGA/Skate Park

Client:	Great Notley Parish Council
Address:	Great Notley Braintree Essex CM77 7YD
Date:	22nd November 2022
Inspector	Jamie Haynes

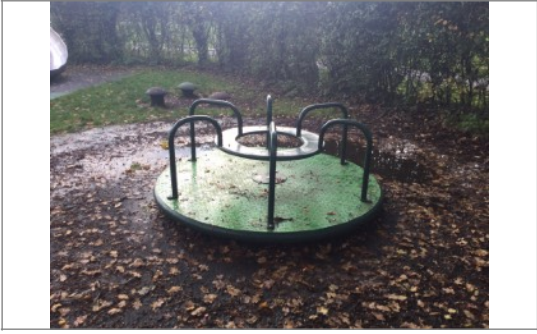
Item	Roundabout				
Supplier	Wicksteed				
Surface	Wet Pour				
Risk Rating Overall	Very Low	Low	Medium	High	Unacceptable
		6

No faults found.
Recommendation:
 No action required, monitor this item.

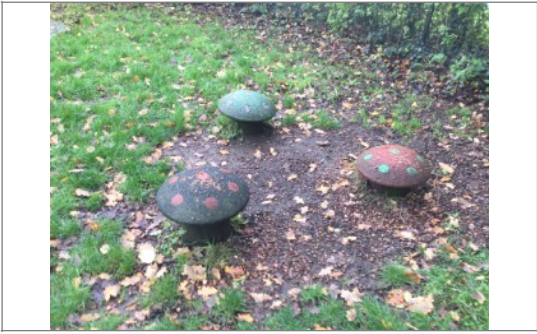
Item	Mushroom Seats				
Supplier	Unknown				
Surface	N/a				
Risk Rating Overall	Very Low	Low	Medium	High	Unacceptable
		5

Worn surfacing.
Recommendation:
 Reinstate as required.

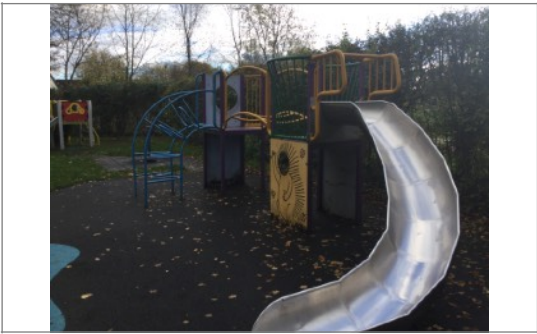
Item	Junior Multiplay Unit				
Supplier	Wicksteed				
Surface	Wet Pour				
Risk Rating Overall	Very Low	Low	Medium	High	Unacceptable
		7

Dents in chute area.
Recommendation:
 Monitor this condition.

Slight delamination evident in places.
Recommendation:
 Monitor to keep rubbed down to prevent splinters.

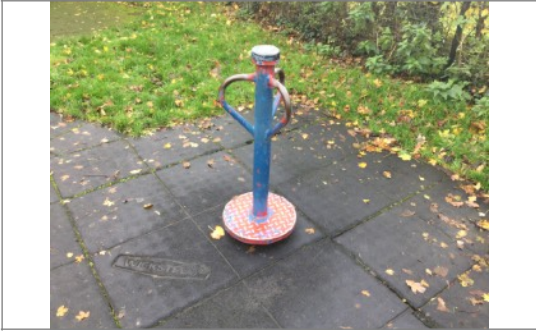
Item	Turnstile				
Supplier	Wicksteed				
Surface	Tiles				
Risk Rating Overall	Very Low	Low	Medium	High	Unacceptable
		7

Gaps evident in tiles.
Recommendation:
 Monitor to repair this condition.

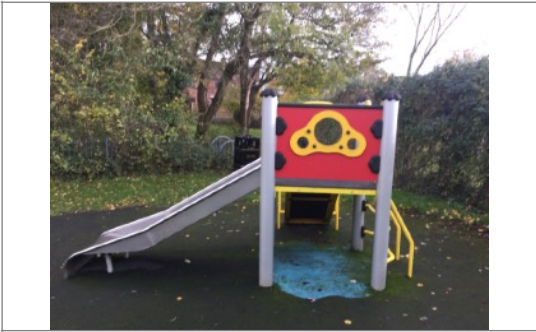
Item	Multiplay Unit				
Supplier	Sutcliffe				
Surface	Wet Pour				
Risk Rating Overall	Very Low	Low	Medium	High	Unacceptable
			8

Dents in chute area.
Recommendation:
 Monitor this condition.

Damage evident to platform.
Recommendation:
 Monitor this condition to repair/replace.

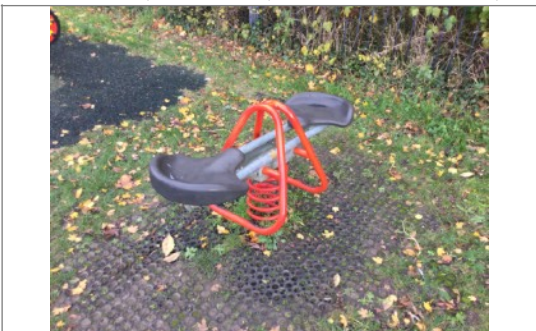
Item	Spring Seesaw				
Supplier	Sutcliffe				
Surface	Grass Matting				
Risk Rating Overall	Very Low	Low	Medium	High	Unacceptable
		5

No faults found.
Recommendation:
 No action required, monitor this item.

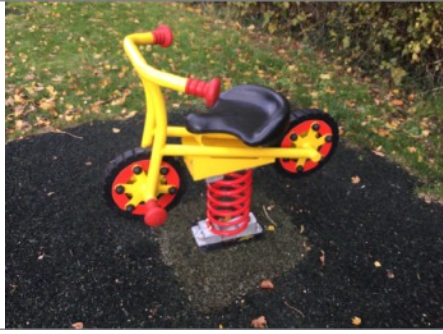
Item	Bike Rocker				
Supplier	Sutcliffe				
Surface	Rubber				
Risk Rating Overall	Very Low	Low	Medium	High	Unacceptable
		5

No faults found during the inspection.

Recommendation:
No action required, monitor this item.

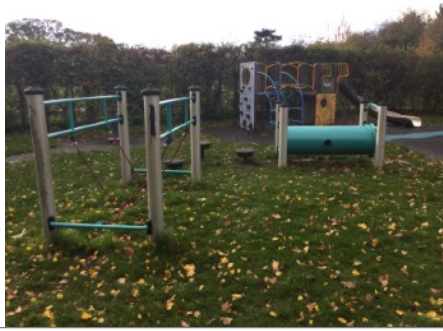
Item	Agility Trail				
Supplier	Sutcliffe				
Surface	Grass Matting				
Risk Rating Overall	Very Low	Low	Medium	High	Unacceptable
		5

No faults found.

Recommendation:
No action required, monitor this item.

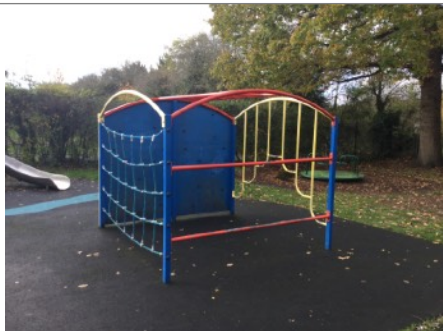
Item	Activity Climber				
Supplier	Unknown				
Surface	Wet Pour				
Risk Rating Overall	Very Low	Low	Medium	High	Unacceptable
			8

Edge shrinkage evident.

Loose fixing(s) evident to hand holds.

Wear evident to rope.

Missing/loose fixings evident.

Recommendation:
Monitor to repair as necessary.

Recommendation:
Consider to retighten loose fixing(s) as required.

Recommendation:
Monitor to repair this condition.

Recommendation:
Replace missing/loose fixings.

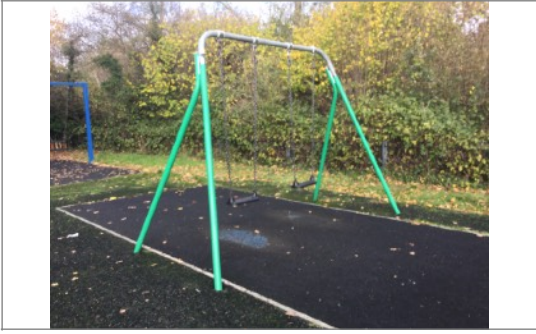
Item	1 Bay 2 Flat Swing				
Supplier	Sutcliffe				
Surface	Wet Pour				
Risk Rating Overall	Very Low	Low	Medium	High	Unacceptable
			8

Chain/connecting link(s) wear evident. Recommendation: Monitor to replace at 40% dia wear.	8
---	---	----------

Slight wet pour damage evident. Recommendation: Monitor this condition.	6
---	--	----------

Wet pour shrinkage in places. Recommendation: Monitor to repair this condition.	7
---	--	----------

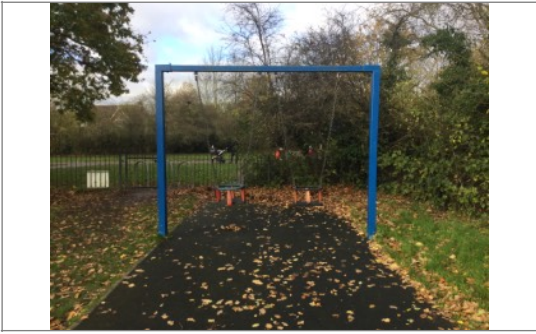
Item	1 Bay 2 Cradle Swing				
Supplier	Unknown				
Surface	Wet Pour				
Risk Rating Overall	Very Low	Low	Medium	High	Unacceptable
			8

Crutch strap slightly damaged. Recommendation: Monitor this to replace if condition deteriorates.	7
---	--	----------

Chain/connecting link(s) wear evident. Recommendation: Monitor to replace at 40% dia wear.	7
--	---	----------

Minimum 2 links required through linkage. Recommendation: Repair this condition.	8
---	---	----------

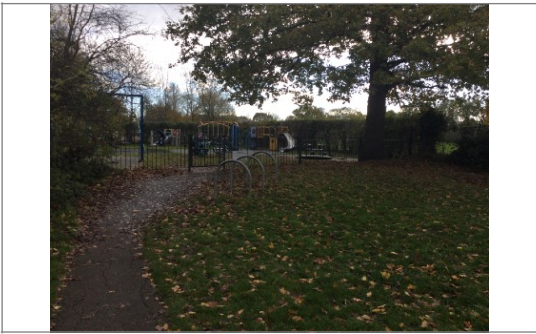
Item	Site				
Supplier	N/a				
Surface	N/a				
Risk Rating Overall	Very Low	Low	Medium	High	Unacceptable
			8

Concrete around seating area cracked. Recommendation: Monitor to repair this condition.	7
---	--	----------

Overgrown thorn bushes evident on site. Recommendation: Consider cutting all thorn bushes back.	8
---	--	----------

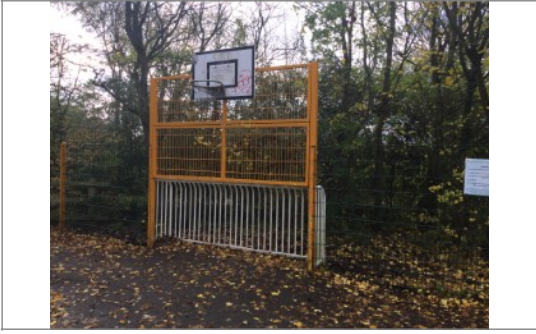
Item	Combination Goal End 1 of 2				
Supplier	Unknown				
Surface	Tarmac				
Risk Rating Overall	Very Low	Low	Medium	High	Unacceptable
		7

Loose fixing(s) evident.
Recommendation:
 Consider to retighten loose fixing(s) as required.

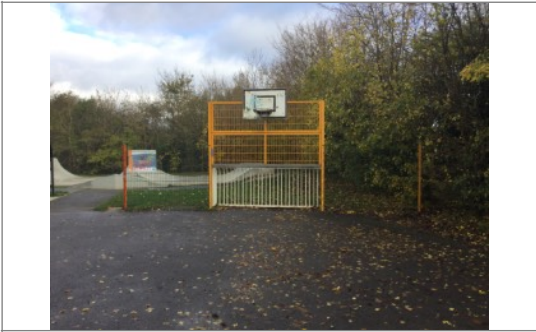
Item	Combination Goal End 2 of 2				
Supplier	Unknown				
Surface	Tarmac				
Risk Rating Overall	Very Low	Low	Medium	High	Unacceptable
		7

Damage evident to surfacing.
Recommendation:
 Monitor this condition.

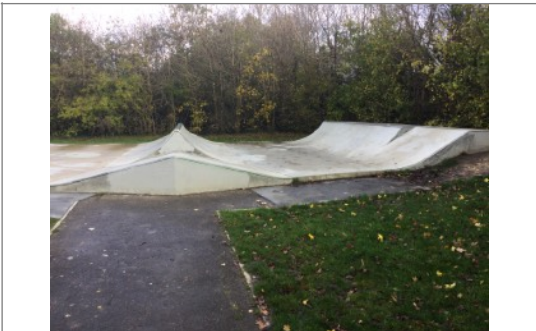
Item	Skate Area - (High Risk Activity Sport)				
Supplier	Bendcrete				
Surface	Concrete				
Risk Rating Overall	Very Low	Low	Medium	High	Unacceptable
				13

Ground level improved.
Recommendation:
 Monitor ground levels.

Cracks starting to form in concrete.
Recommendation:
 Monitor this condition.

Damage evident to edges of concrete base.
Recommendation:
 Monitor this condition and repair as required.

Obscene graffiti evident on item.
Recommendation:
 Remove obscene graffiti.

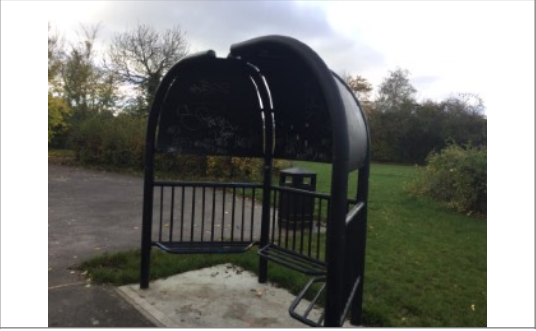
Item	Shelter				
Supplier	Unknown				
Surface	N/a				
Risk Rating Overall	Very Low	Low	Medium	High	Unacceptable
	3

No faults found.
Recommendation:
 No action required, monitor this item.
